# Flood Investigation Report

Pix Brook

Stotfold

CB/FLO/15/09003

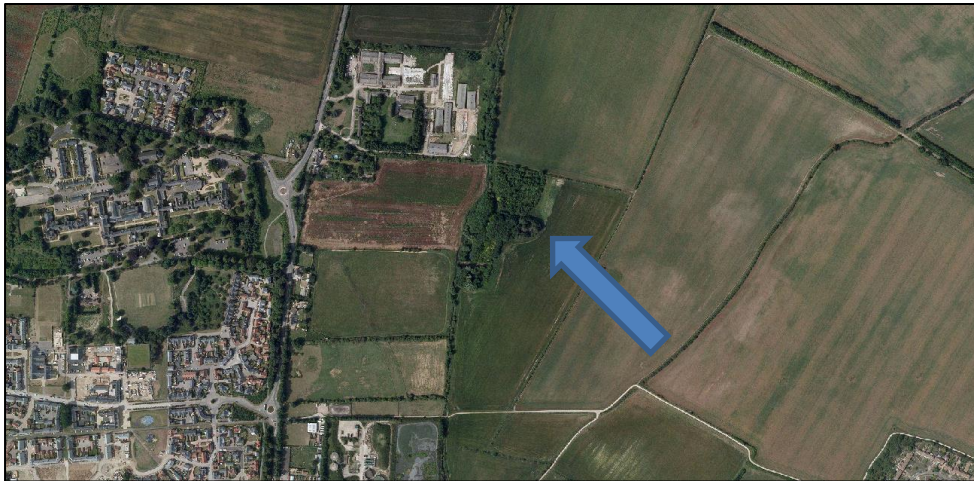
Having walked the section of the Pix Brook from the footpath by the sewage works north to the A507 I am of the opinion that the majority of the debris at Brook Street came from the area of woodland as indicated below.

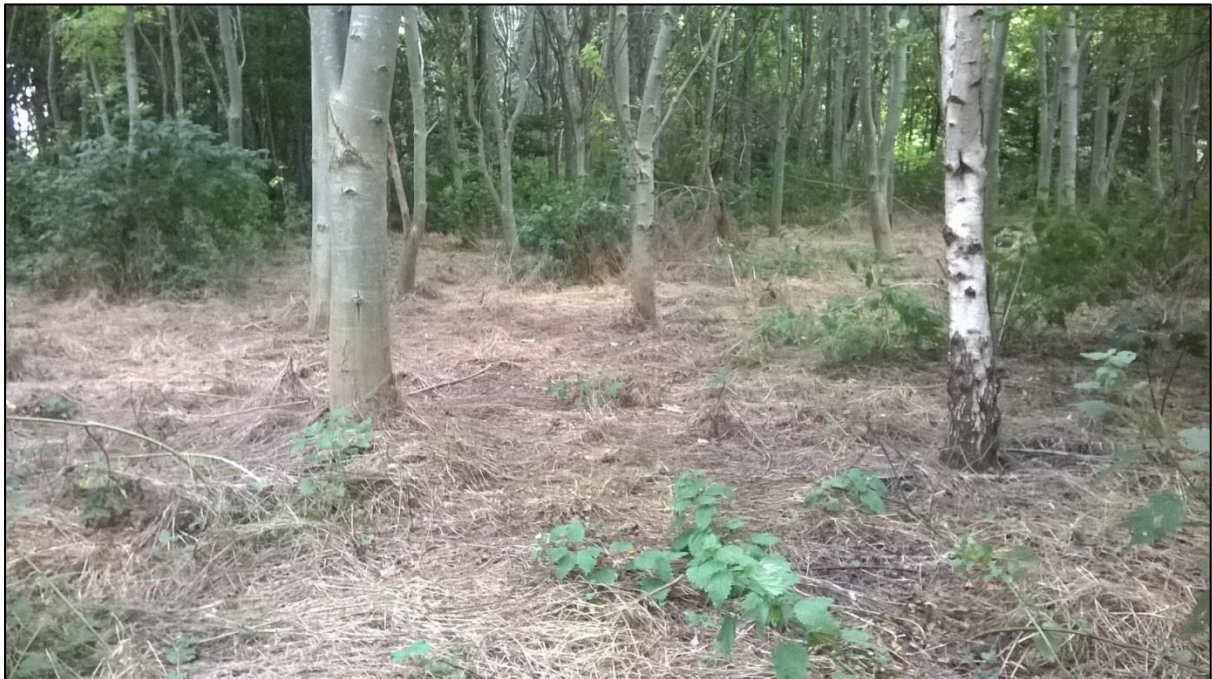
This is a piece of mixed broadleaf plantation woodland which has a heavy understory of nettles but little else. This means that any fallen deadwood can be readily washed in to the brook as there is nothing to hold it back as the following photo shows.

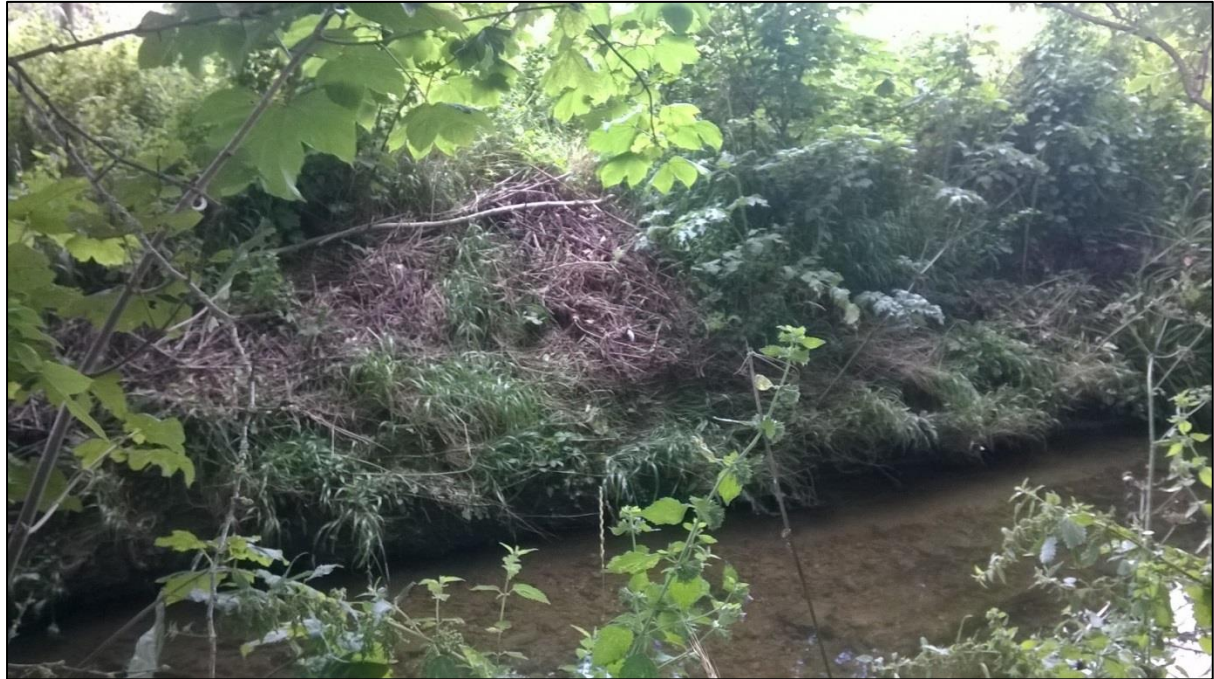
You can see that the woodland has been inundated as water has washed down the hill from Norton and where it has burst its banks, carrying debris back into the flow.

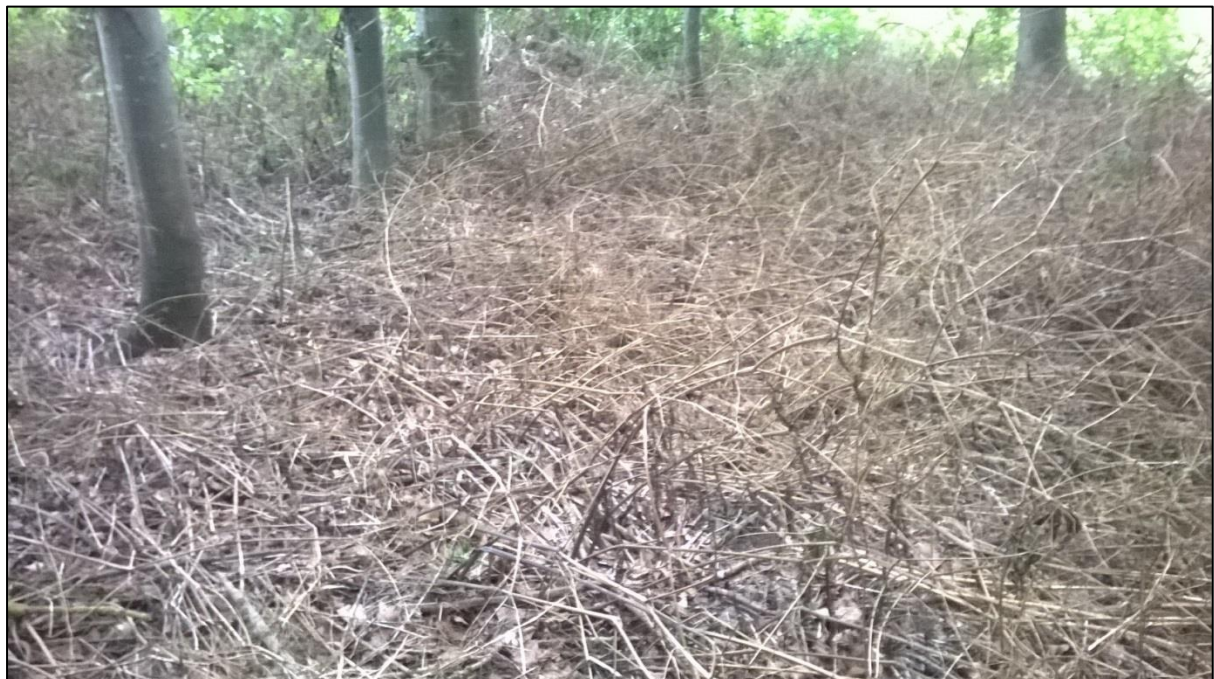
Photograph taken approx. 200m North of the footbridge and shows how high flows were experienced hence inundating the woodland further downstream.

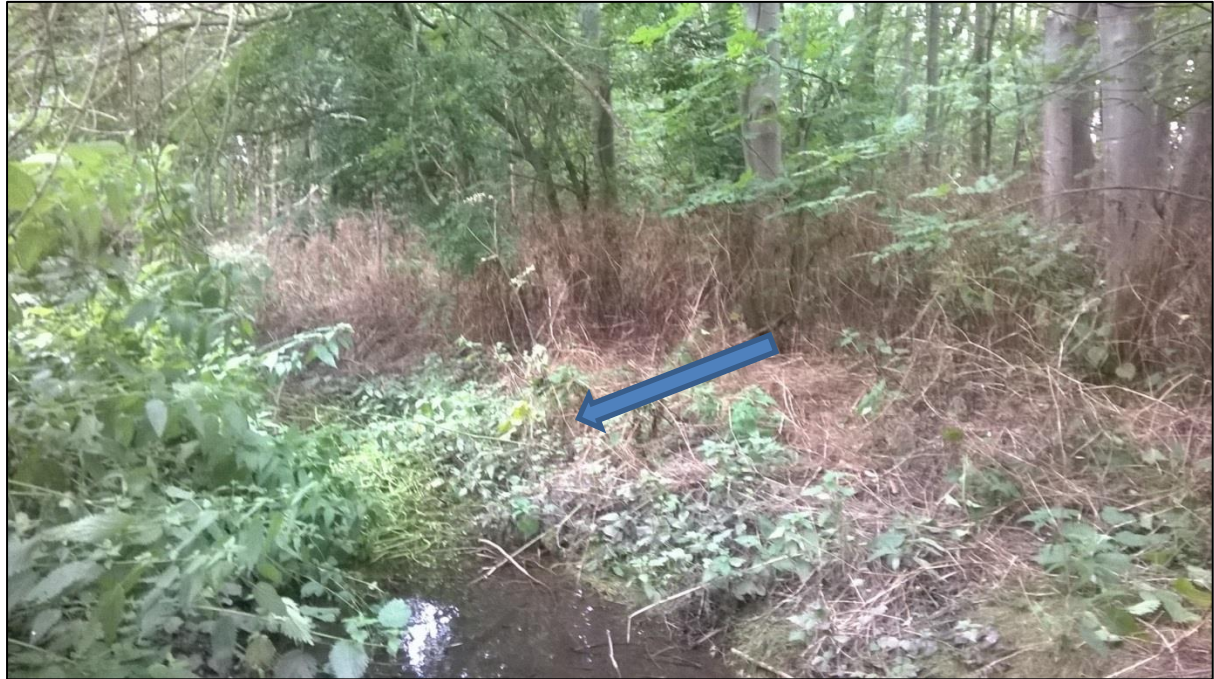
Having looked again at the 'weed' that we saw I think it was watercress. Whilst the woodland did contain large swathes of hogweed (not of the Giant variety) I don't believe it to be this. The following photo shows a small patch of watercress left up a small tributary and this looks just like the weed pulled out at Brook Street so it could have been there was a larger stand of it in this woodland that has become dislodged and flowed downstream.
