Flood Investigation Report

Aspley Guise Cranfield Dunstable Stotfold

Report Reference: CB/FLO/16/00001

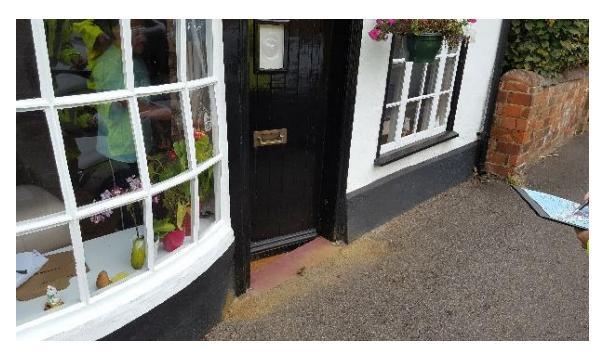
- 5.2.2 The local topography causes surface water to flow along Church Street, Woburn Lane and West Hill and towards the lower lying Bedford Road and The Square. Ultimately, these flows are heading toward the watercourse north west of the village centre.
- 5.2.3 16 properties were recorded as being affected by flooding. During the site visit nine residential properties were determined to have been affected by internal flooding, it was not possible to confirm how the other properties were affected.
- 5.2.4 Many affected properties were observed as having low thresholds compared to the external ground level (Figure 6). Surface water runoff from roads therefore has an unobstructed route to properties due to higher road levels and dropped kerbs (Figure 7).

FIGURE 6: TYPICAL PROPERTY THRESHOLD LEVEL, 2016

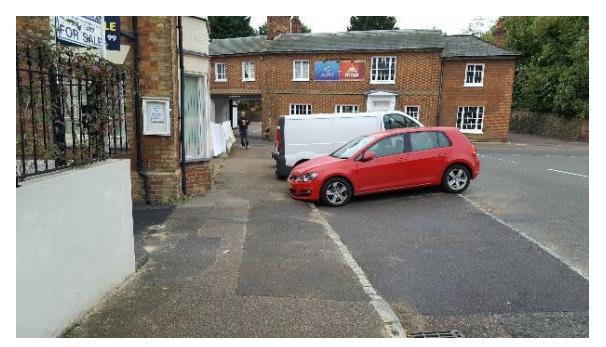
FIGURE 7: HIGHWAY SURFACE AND KERBING, 2016

Authority/ Stakeholder	Recommended actions to manage the risk of flooding in the future for <u>Aspley Guise</u>
	Investigate an option of increasing kerb heights along The Square, West Hill and Bedford Road to provide some protection to properties. Further works downstream would be required to collect and discharge the water retained within the road. SuDS should be incorporated into any improvement works where feasible.
Anglian Water	To inspect and maintain the foul water sewer serving Aspley Guise to ensure the system is returned to operating condition.
	To consider liaison with residents regarding the existing discharge of surface water from their properties into the foul sewer, which may otherwise lead to overloading and foul flooding.
	To restrict new connections or discharge into the public foul system, where practical.
	To monitor the frequency of foul flooding and consider improvements to the network or prevention of surface water entering the system. This should be developed through collaboration with stakeholders and consideration of a future scheme under AMP6/7 to retrofit SuDS within the area under to reduce surface water runoff and manage it more sustainably.

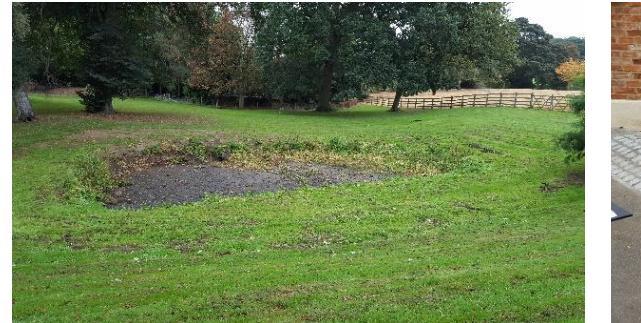
FIGURE 8: POND REINSTATED IN GROUNDS OF ASPLEY HOUSE, 2016

- 5.2.5 During CBC investigations and maintenance activities after the flood event, a pond was uncovered and re-instated in the grounds of Aspley House (Figure 8). This is thought to provide a small volume of storage through an overflow pipe from the local drainage system. The ownership and purpose of the drainage system is largely unknown at the time of this report being published.
- 5.2.6 During the site visit sandbags were observed to still be in place, four months after the event, as an attempt to offer some protection against future events at a number of properties.

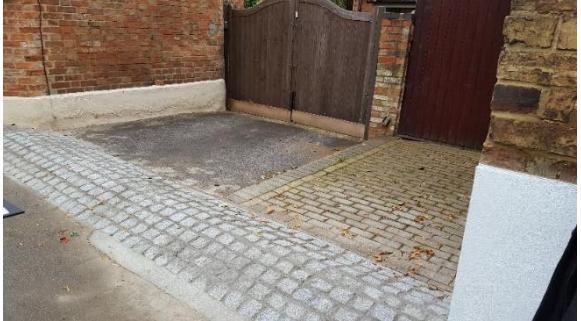
FIGURE 9: RAISED HUMP TO DRIVEWAY ACCESS, 2016

5.2.7 A number of properties were observed to have part/completed construction works. One property has increased the level of rendering up the external wall and constructed a raised hump to the driveway entrance (Figure 9).

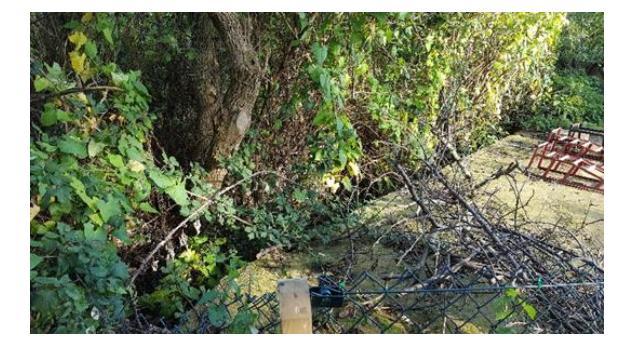
5.3.5 Surface water drainage of the airfield (to the west of Merchant Lane) is largely unknown. Given the topography of the airfield, it is likely that water would have partly runoff east towards Merchant Lane and then north easterly towards the receiving watercourse. Occupiers of Maltings Close explained that flood waters entered from the front and rear of the properties. A ditch was identified during the site visit along the boundary of properties along Maltings Close and the airfield. This was heavily vegetated during the site visit (Figure 11).

FIGURE 10: DITCH AT THE REAR OF THE PROPERTIES ON MALTINGS CLOSE

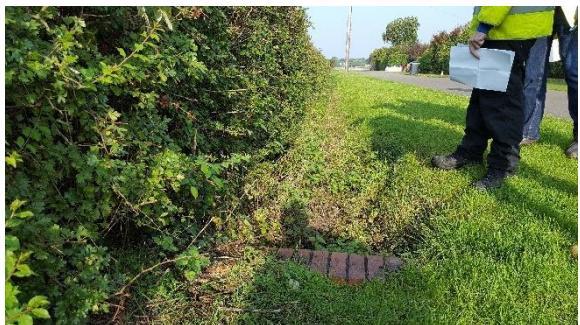
FIGURE 11: DITCH RECEIVING SURFACE WATER SEWER DISCHARGE

Authority/ Stakeholder	Recommended actions to manage the risk of flooding in the future for <u>Cranfield</u>
Anglian Water	To inspect and maintain the surface water sewer outfall in Merchant Lane to ensure it has a free discharge.
	To understand the impact the small ditch discharge pipe has on the operation of surface water sewers.
	To work in partnership with other stakeholders to identify opportunities for improvements to the network, and receiving systems where necessary, particularly along Merchant Lane and High Street.

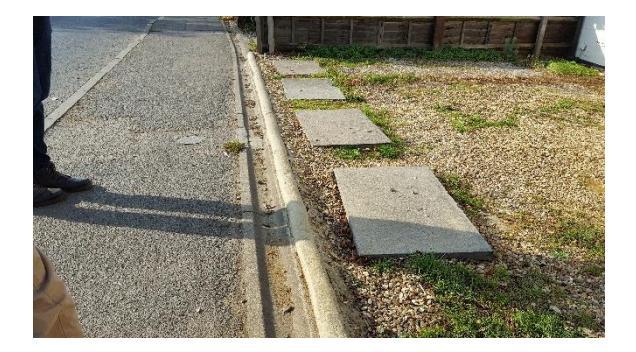
FIGURE 12: CONCRETE CHANNEL AT THE REAR OF THE FOOTWAY

5.3.7 Properties on the High Street appear to be lower than the carriageway and surrounding land. Residents also suggested that cars driving through standing water on the High Street at the time might have caused it to exceed the carriageway at low points, it was thought that the volume of traffic through the village may have been increased due to other routes being closed or impassable due to flooding elsewhere in the area. Attempts have been made to provide some protection to properties previously, it is thought by CBC Highways (Figure 12).

Authority/ Stakeholder	Recommended actions to manage the risk of flooding in the future for <u>Cranfield</u>	
	Investigate options to increase kerb heights along High Street to provide some protection to properties. Investigate the effect of speed tables on surface water flows and any options available to reduce the frequency of surface water ponding. This should not be considered in isolation from the nearby property thresholds. Any improvement scheme would require a detailed design to ensure the risk from flooding was not increased.	
	Review of gully cleaning schedule to increase frequency in the areas identified at higher risk of flooding.	
CBC: Local Planning Authority	To consult the LLFA on any planning application affecting land to the south of Crawley Road to ensure the development proposals include SuDS and fulfil the opportunity to provide betterment to the local area. This includes restricting surface water runoff to greenfield rates and promotion of reinstating more natural land drainage.

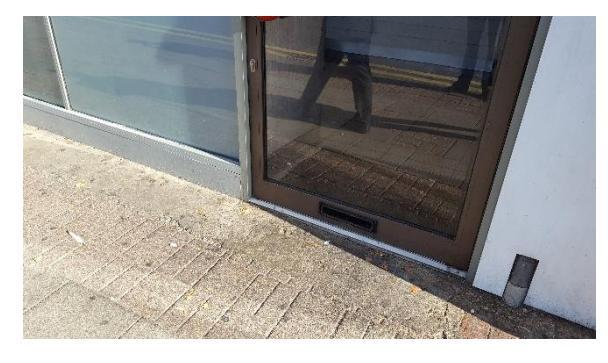
- 5.4.4 Typically, thresholds of properties on High Street South were level with the footway (Figure 13) and some had lower ingress routes including basement entrances. One property was observed to have a flood gate fitted to the front door (Figure 14). It is believed that the property still experienced flooding to the basement which suggested other routes of ingress.

FIGURE 13: TYPICAL THRESHOLD LEVELS

- 6.5.4 Commercial properties have thresholds level with the footway that offer little protection to any depth of flood water.
- 6.5.5 Vehicles continued to use the road, driving through flood water and causing bow waves towards the properties which caused further flooding.

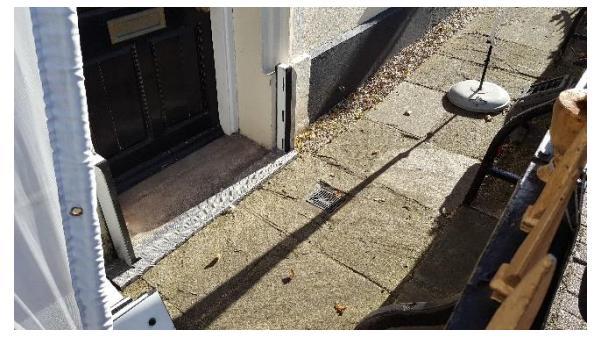
FIGURE 14: FLOOD GATE INSTALLED ON PROPERTY

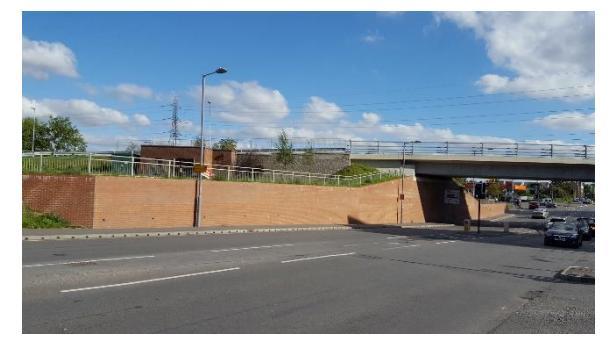
- 5.4.5 The A5, High Street South is currently maintained by Highways England and due to be transferred to CBC in the future.
- 5.4.6 The A505, Church Street under the busway is significantly lower than the surrounding area (Figure 15). During the flooding, water was deep enough to strand cars and the road was closed to the public. Surface water was able to enter the public foul sewer, which is thought to have caused overloading of the system and foul flooding under the busway (Figure 17).

- 5.4.7 A pumping house next to the busway was observed during the site visit (Figure 15). Anglian Water has confirmed ownership although it is unclear exactly what drainage this serves at the time of this report being published.

FIGURE 15: VIEW OF CHURCH STREET LOOKING EAST AND PUMP STATION

Authority/ Recommended actions to manage the risk of flooding in the future for Dunstable Stakeholder Reconsider the development of a scheme to improve the highway drainage system within Church Street and High Street South. A scheme may look to include: additional or larger gullies to improve collection of runoff; above ground alterations, such as raised humps, to slow runoff and improve the collection of it; improved carrier drain with online storage; retrofitting of SuDS to better manager surface water. Should a drainage scheme not be possible, a Flood Response Plan could be developed at Church Street to manage a flood event as it happens. This could include automated road closure signs to warn drivers the road is unpassable and reduce response costs from sending operatives to site. Discuss the transfer of responsibly for the A5, High Street South with Highways England and the possibility of improvements given the flooding event. Drainage records should be requested and Highways England asked to survey the area if not available. To inspect the surface water and foul sewers within Church Street to their outfall and undertake **Anglian Water** maintenance where required. The capacity of these sewers could be identified to inform future decisions when considering new connections. The functionality and capacity of the pump station and associated storage shaft should be further understood and the findings shared with the LLFA and CBC Emergency Planning team. To consider a future scheme under AMP6/7 to retrofit SuDS within the area to reduce surface water runoff and manage it more sustainably. To continue to work with occupiers to improve their understanding of appropriate measures they could take to protect their property. This could include Property Resilience Measures (PRM) at High Street South particularly given the interest from commercial entities. Consideration should be given to supporting a potential scheme through funding contributions. Liaison with the LLFA and occupiers should be sought.

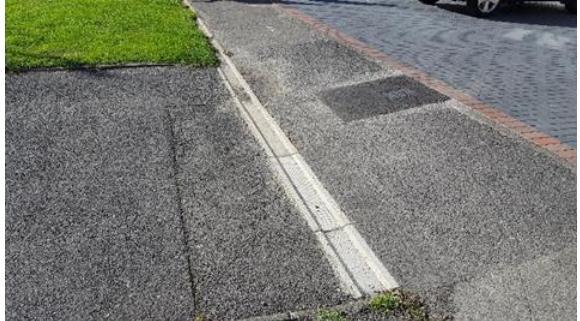
- 5.4.9 Residential properties were affected internally by flooding across Dunstable. Typically, these properties were lower than the road and had impermeable driveways sloping towards the property. Drainage channels, additional gullies and raising of kerbs have been installed by CBC Highways in some of these locations as an attempt to offer some protection against frequent flooding (Figure 16).

FIGURE 16: EXAMPLE OF FOOTWAY DRAINAGE

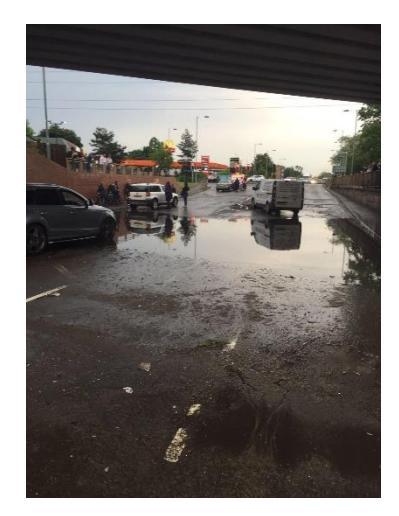
FIGURE 17: FOUL AND SILT DEBRIS FOLLOWING FLOODING

6.5.8 Surface water was able to enter the foul public sewer which is thought to have caused overloading of the system and foul flooding under the busway.

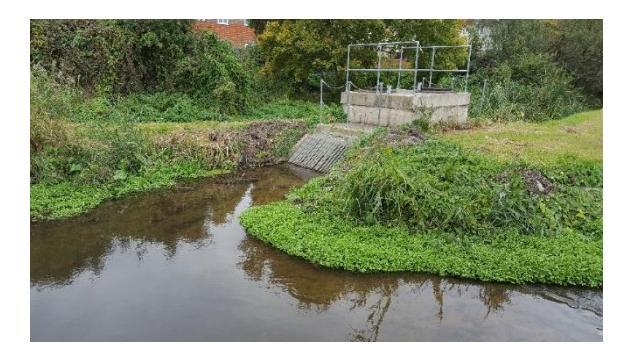
FIGURE 18: POINT OF PIX BROOK SPLITTING INTO TWO CHANNELS NEAR VALERIAN WAY

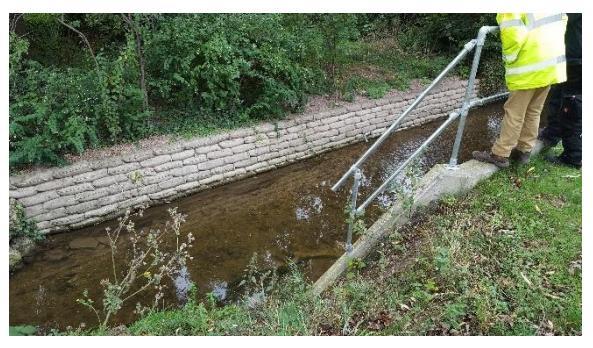
FIGURE 19: EXAMPLE OF EROSION PROTECTION WORKS

- 5.5.10 During the 2016 site visit, evidence of erosion protection was observed at a number of locations downstream of the confluence of the old and new Pix Brook channels (Figure 19). A number of properties on Coppice Mead were also observed to have built brick walls along the left bank of the Pix Brook (Figure 21).

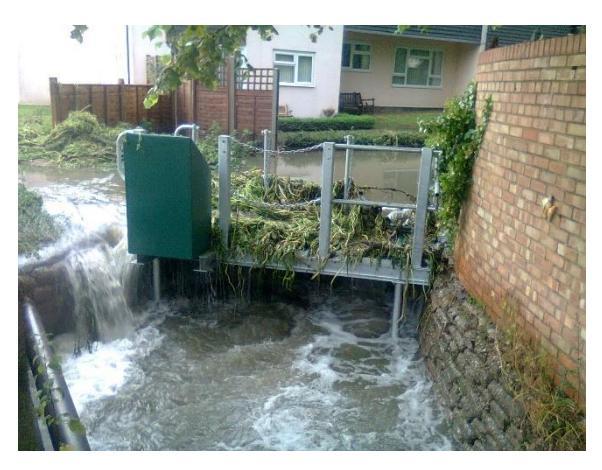
- 5.5.5 A previous section 19 report was compiled by CBC in response to flooding experienced in Stotfold on 4th July 2015. During this event debris was conveyed along the Pix Brook which overwhelmed and blocked the trash screen located on the upstream side of brook street, causing water levels upstream to rise rapidly and flood the local area. In the 2015 report debris was found to mainly consist of)watercress plant (figure 20), which is fast growing in the spring and it is thought nutrients from the sewage treatment works to the south of Stotfold increased its growth within the Pix Brook. Under instruction by the Police following the 4th July 2015 flood event, the IDB removed the trash screen at Brook Street. Flooding occurred again on 17th July 2015 when the Hitchin Road culverts became partially blocked with vegetation and debris.

FIGURE 20: WATERCRESS PLANT OBSTRUCTING DEBRIS SCREEN AT BROOK STREET DURING THE 2015 FLOOD

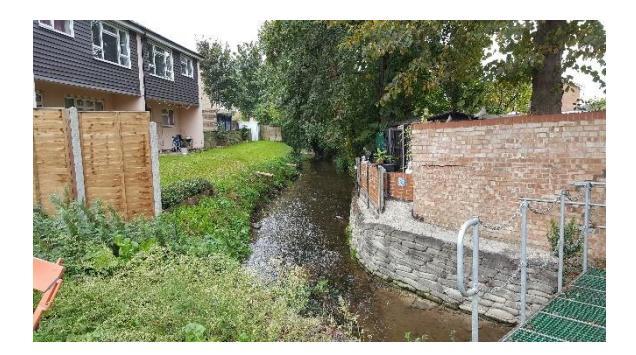
FIGURE 21: BRICK WALLS CONSTRUCTED ALONG THE BANK OF PIX BROOK, 2016

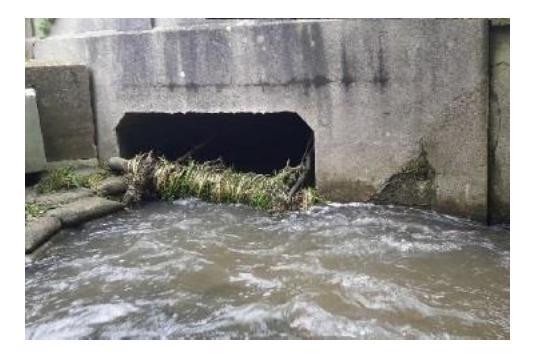
FIGURE 22:BOX CULVERT AT HITCHIN ROAD PARTIALLY BLOCKED BY DEBRIS, 2016

- 6.6.1 Due to the rainfall event on 12th June, the flow within the Pix Brook at the time was estimated have to a 3.33% annual probability.
- 6.6.2 The twin culverts at Hitchin Road have a maximum capacity at which they are able to pass water. It is understood that the flow of water within the Pix Brook was partially restricted at this point due to debris, which caused water levels to rise upstream.

- 6.6.5 Areas between Stotfold and Letchworth are relatively rural which presents a greater opportunity for debris and vegetation to fall into the Pix Brook. Post the flood event, debris was found at the face of the box culvert at Hitchin Road that would have raised the water level upstream and increased the risk of flooding.

Authority/ Stakeholder	Recommended actions to manage the risk of flooding in the future for <u>Stotfold</u>
	Any maintenance regimes for these structures must also take into account the debris loading in the Pix Brook.
	Any improvement works planned should be advised by a wider catchment study of the Pix Brook to ensure wider objectives and flood risk benefits are achieved.
	To review the Risk Assessment and Method Statement for the undertaking of maintenance to the culverts at Brook Street and Hitchin Road during flood conditions.
	Advise CBC Highway Authority of compromises in asset performance of the culverts during flood events.
	To work with stakeholders to support measures at Stotfold which would empower the local community to increase their resilience against flooding (subject to available funding and prioritisation).
Continue to liaise with the Environment Agency regarding the representation within the Flood Planning by sharing their hydraulic modelling to support the challenge.

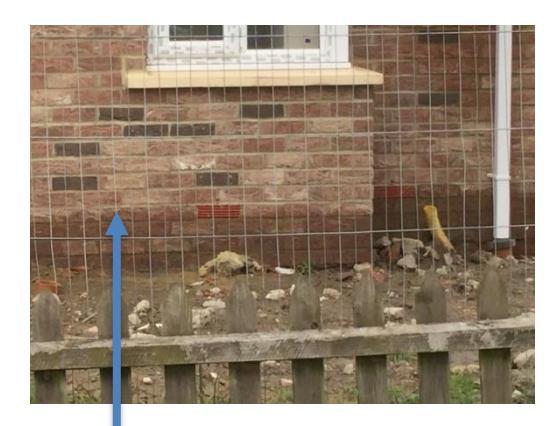
FIGURE 23: WATER MARKS LEVEL WITH AIR BRICKS ON NEW PROPERTIES, 2016
